SEISMIC HAZARD EVALUATION

RANCHO PALOS VERDES CIVIC CENTER BUILDINGS

30940 HAWTHORNE BOULEVARD
RANCHO PALOS VERDES
CALIFORNIA 90275

BREIHZOLZ QAZI ENGINEERING, INC.
1852 Lomita Blvd., Suite 210, Lomita, California 90717
EMAIL: engineer@bqe.com <http://www.bqeinc.com/>
TEL: 310-530-3050 FAX: 310-530-0184
Project 2K-027Q October 25, 2000

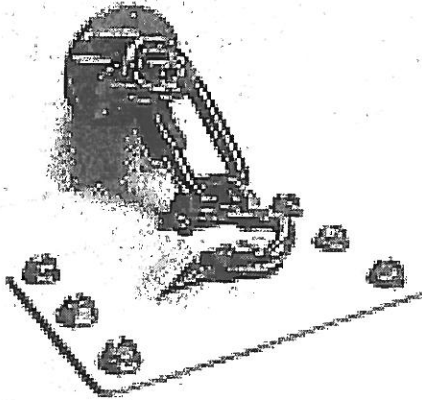
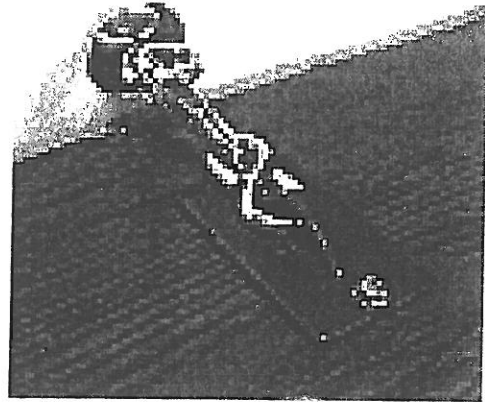
RECOMMENDED NON-STRUCTURAL RETROFIT

The above pictures show the top of filing cabinets and/or bookcases anchored to adjacent walls. This type of anchorage can also be applied to other tall furniture in the building. Tall furniture is likely to overturn during a major earthquake. Desktop computers may move during a major earthquake but these are not likely to fall down from desks. Computer anchorage shown on the pictures below is only recommended for critical computer equipment such as computer servers. The suspended ceiling system in the building is not expected to suffer extensive damage. The partition walls for the offices divide the ceiling into numerous sections that are actually confined by the walls. The picture to the left shows extensive damage from overturn filing cabinets and bookcases.
